CASE STUDY OF HOW AN ENVIRONMENTAL PROTECTION ACTIVITY ADVERSELY AFFECTED THE PERFORMANCE OF A HIGH QUALITY PAVEMENT AGGREGATE

Prof. Emeritus Peter Hudec, University of Windsor, Canada

Arthur Fulton, Fulton Hogan, New Zealand

Dr Bryan Pidwerbesky, Fulton Hogan, New Zealand

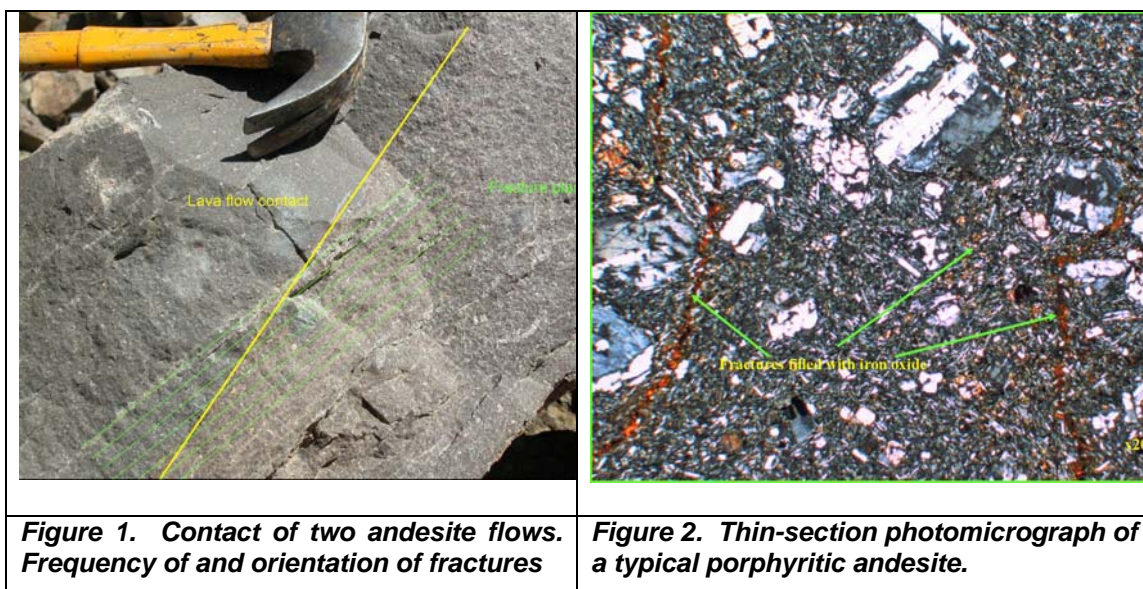
Figure 2 shows a typical thin section photomicrograph. Thin section examination shows angular single crystal phenocrysts that are composed of plagioclase laths and minor hypersthene crystals; plagioclase laths exhibit simple twinning, suggesting albite-oligoclase composition, and are sometimes zoned, suggesting slow cooling before eruption. Lithic clasts about two to six times larger than the individual phenocrysts are generally rounded, and filled with a mixture of plagioclase and hypersthene/augite crystals. The phenocrysts and clasts occasionally show

ragged edges, suggesting rotational abrasion during flow and emplacement. The groundmass consists mostly of elongate prisms of simply twinned plagioclase, with minor crystals or nests of augite. Minor devitrified volcanic glass is present in the ground mass and as filling of fractures. Although generally randomly oriented, the groundmass prismatic crystals show local alignments of crystals into swirls, indicating lava mass flow; some are aligned in zones, indicating fluid flow. The rock is peppered with abundant, small magnetite grains. All thin section specimens studied showed sub-parallel fractures that were variously filled with devitrified glass (tridymite), clay (montmorillonite), some calcite (usually associated with clay), magnetite and iron oxide (limonite).

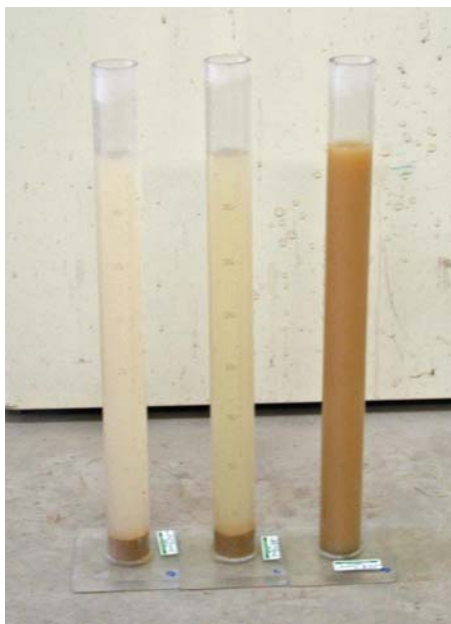
Figure 3. Settlement columns containing treatment water (left and centre), and distilled water

Two samples of clear processed water were collected, one representing a light, and the other a heavy load of clay suspension that was treated. A 'virgin' untreated clay from the scalping pile was obtained, and wet-sieved to obtain the minus 0.075 mm fraction common in clay suspensions. A 100 ml suspension of this fraction was mixed with 900ml of the two treated water samples, and one distilled water sample. The two treated water sample immediately flocculated the suspension; the distilled water sample retained the suspension for several hours. This proved that the treated water contained a large amount of CF. The three columns of water shortly after the experiments are shown in Figure 3. The processed water contained sufficient CF to quickly settle the clay suspension.

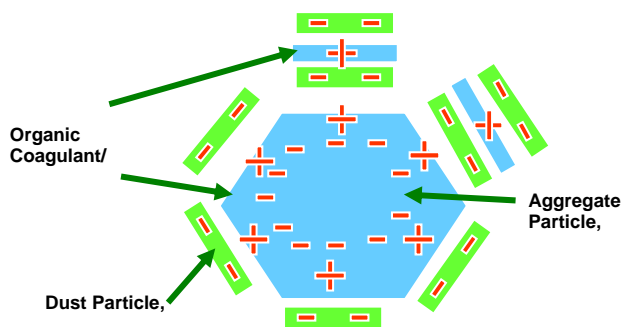
Aggregate and clay particle surfaces are negatively charged, as are all surfaces. The negative charge is due to broken bonds at the surface, and imperfections in the internal lattice of the minerals. Water is a polar fluid with net negative and positive charge; water molecules are attracted to the negative surfaces, as are any positively charged molecules. The flocculating and coagulating agents used in the water treatment are large, positively charged polymer molecules. The chemical-laden water used in secondary and tertiary processing was attracted to the chip surface and coated the particle with CF. Dust produced during the processing was negatively charged, and is attracted to the coating. The dust particles adhered to the aggregate due to *van der Waals* force. There were several layers of dust coatings produced by this process. The process is illustrated in Fig. 4. Aggregate showing the dust coatings is shown in Fig. 5. The dust is essentially ground silica-rich rock powder containing mostly feldspar.

Figure 4 Dust coating process of aggregate

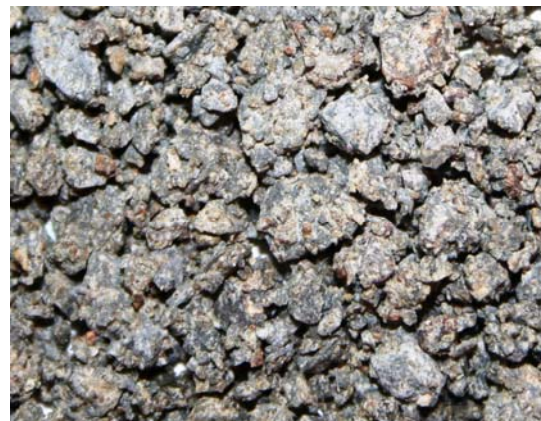
Figure 5. PAP aggregate coated with dust and fine particles.

Because of the *van der Waals* forces, the dust cannot be readily separated from the aggregate by simple washing. Soaking the aggregate in water allows the polar water molecules, over time, to replace the CF polymer molecules holding the particles together, dispersing them.

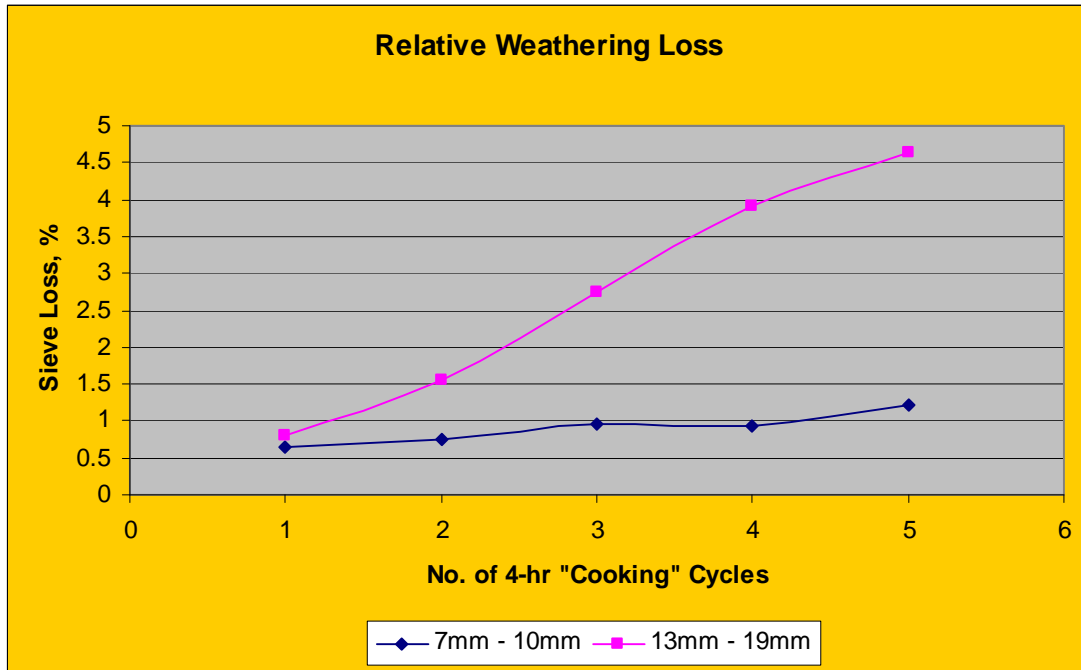
The sieve loss is shown in Figure 6. The coarser 13 mm to 19 mm chip shows a larger loss than the fine chip, due to greater incidence of shear planes in larger particles and cleaving along them. The “cooking” transformed the volcanic glass filling the fracture planes into clay, iron oxide and calcite, weakening the bond. The weathering effects are described below. The transformation of volcanic glass was confirmed in the petrographic analyses of thin sections.

Some of the loss can also be attributed to the thermal stress and abrasion encountered during the test.

Figure 6. Results of simulated rapid chemical weathering test

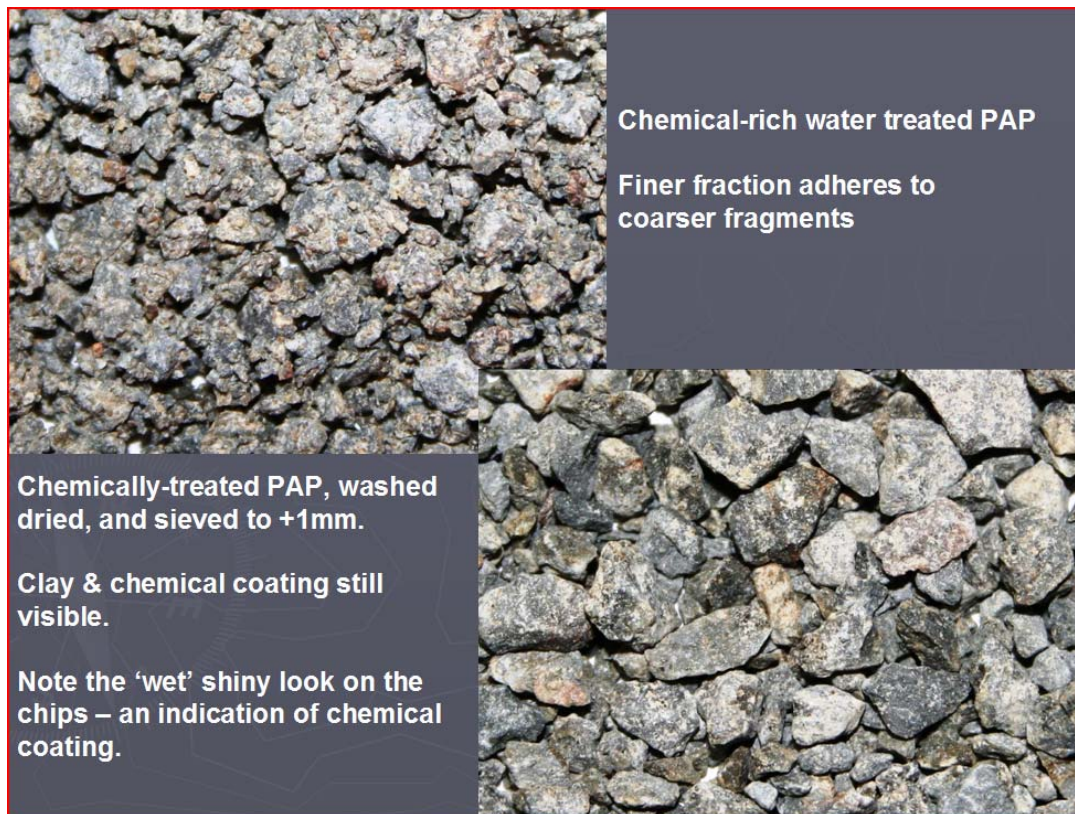
When treated PAP material was examined under a binocular microscope, it was noted that the CF used in the wash water acted as a temporary 'glue' to bind finer particles to coarser ones – see figure 7. Washing and agitating the sample 'unglued' the particles. In blending the aggregate for placement, the 'glued' particles will pass for a larger chips. After exposure to rain or groundwater, the 'glued' particles will disaggregate, resulting in a greater proportion of fines than intended. The fines will be become concentrated near the base. The presence of CF on the fines attracts water, causing water content to increase.

Figure 7. Adherence of dust and fine particles to due to chemical-rich wash water in PAP product from the quarry.

The primary goal of remedying the problem was to remove or reduce the CF in the wash water. As long as the treated water is slightly turbid, i.e., contains some suspended dust/clay particles, the water is relatively free of CF, or the amount of CF is in small enough quantity not to affect the integrity of the aggregate surface. A simple test, similar to that described by Figure 4, is carried out periodically on site to assure that the water is CF free. To further guarantee that no or little CF is available in the secondary crushing process, the water treatment process was modified by reducing the concentrations of CF to levels that provided an acceptable level of
